ENVIRONMENTAL SERVICE AND TECHNOLOGY CORPORATION

Regarding: Inspection # I 08-076
Facility ID #: 2000271 DC Materials Washington, DC
ENSAT Project #: 07A-2714

Fueling System Suction Line

Heating System Suction Line

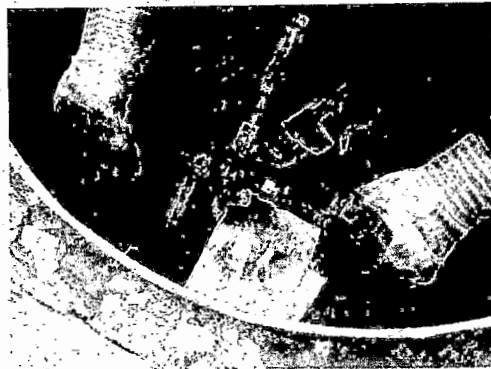
Picture 2

2. ENSAT disconnected the supply line(s) for the heating oil lines in the sump (See picture 2) on top of the tank. No residual fuel was identified in the lines when they were disconnected.
3. No Fuel was evident in the tank riser when the lines were disconnected.
4. ENSAT did not disconnect the lines at the pump in the drive through bay and pour fuel down these line(s) due to heavy truck traffic in this area loading concrete product.
5. The elevation of the pump was determined to be above the top of the sump, indicating a slope back to the tank

Piping Sumps for the fuel pump and heating oil systems. All lines were disconnected and found to be free of fuel (i.e. they drained back to tank). Prior to checking the fuel pump approximately 10 gallon of fuel was pumped through the line and then poured back down the disconnected line. All fuel drained back to sump.

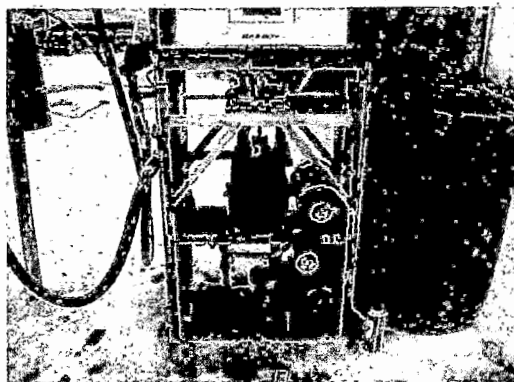
Picture 5

Pictured above is the pump prior to removal of the check valve and with the check valve removed.

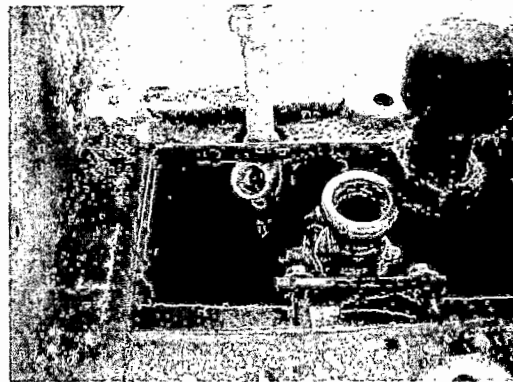
Picture 6

1. Approximately 10 gallons of fuel were pumped from the tank through the pump and poured back down the supply line (See picture 6) directly under the pump. The material drained to the tank. No fuel was identified in the line when it was removed.
2. A check valve was identified in the supply line in the pump cabinet (See picture 3 and 4). The check valve appeared to operate correctly.
3. The valve was removed and found to be operable.
4. The line was disconnected at a joint in the tank sump (see picture 1) after the product was poured into the supply line under the pump. The line had no accumulated product and was found to be empty.
5. The elevation of the pump was determined to be above the top of the sump, indicating a slope back to the tank.
